DESIGN, FABRICATION, TEST, AND EVALUATION OF A PROTOTYPE 150-FOOT LONG COMPOSITE WIND TURBINE BLADE

Herbert W. Gewehr Kaman Aerospace Corporation Approved for public release

September 1979

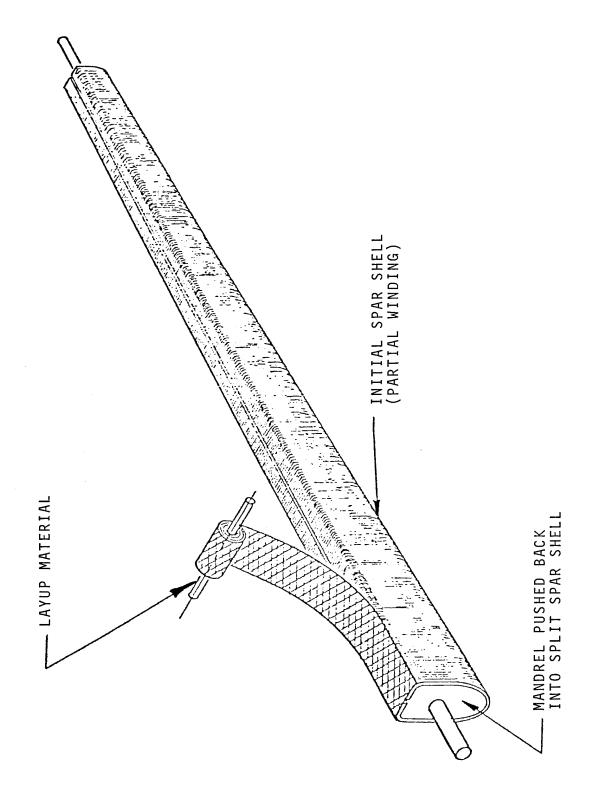
Figure 62. Repair of Spar Shell Aft Web.

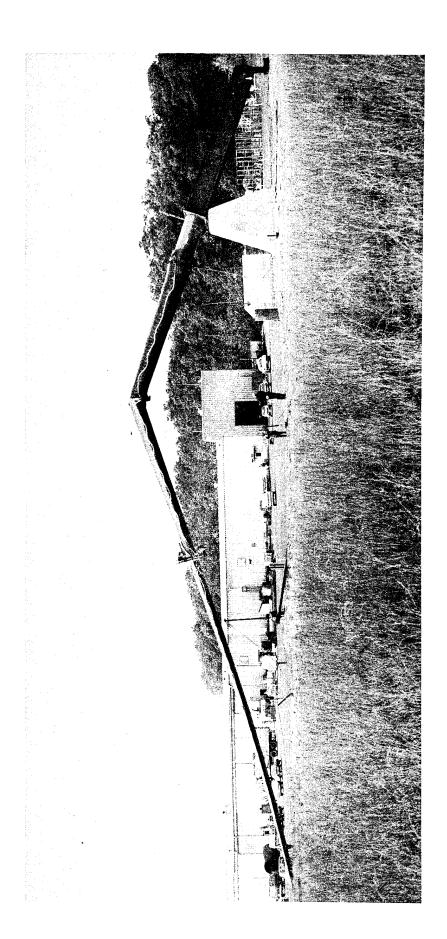
scale blade tests were performed which included natural frequency tests, deflection and stiffness measurements, proof load tests, and a flatwise bending test to failure. Failure occurred by local crippling of the spar wall at 109 percent of the design load (a hurricane wind condition, 164 mph at rotor hub height). The origin of the crippling failure was a flaw in the spar wall associated with the prototype fabrication process and soft tooling peculiar to this one-of-a-kind wind turbine blade. A subsequent test of the surviving outboard end of the blade (100 ft long) successfully sustained a flatwise bending moment almost 3 times the design load. This later test demonstrated that large knockdown factors from theoretical crippling strength predictions are not necessary for pure monocoque glass/epoxy structures of this type providing no serious material defects (such as the visible flaws present at the location of the crippling failure) are present.

Figure 82. 150 Foot Blade After Failing Load Test.

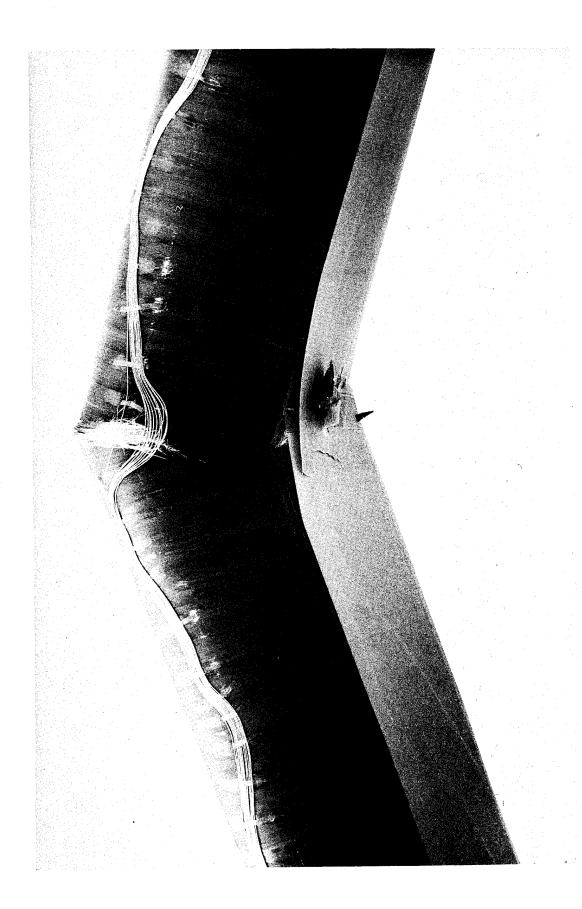
Figure 83. Crippling Failure of Blade Spar.

This test demonstrated that large knockdown factors from theoretical crippling strength predictions are not necessary for pure monocoque glass/epoxy structures of this type, provided no serious material defects (such as the local bulges present at the station 45 failure location) are present.
